DEPARTMENT OF TRANSPORTATION**DIVISION OF ENGINEERING SERVICES**

Contract #: 04-0120F4Cty: SF/ALA Rte: 80 PM: 13.2/13.9File #: 69.28**WELDING INSPECTION REPORT****Resident Engineer:** Pursell, Gary**Address:** 333 Burma Road**City:** Oakland, CA 94607**Report No:** WIR-004222**Date Inspected:** 23-Oct-2008**Project Name:** SAS Superstructure**OSM Arrival Time:** 1800**Prime Contractor:** American Bridge/Fluor Enterprises, a JV**OSM Departure Time:** 730**Contractor:** Zhenhua Port Machinery Company, Ltd (ZPMC), Changxing Island **Location:** Shanghai, China**CWI Name:****CWI Present:****Yes No****Inspected CWI report:** Yes No N/A**Rod Oven in Use:** Yes No N/A**Electrode to specification:** Yes No N/A**Weld Procedures Followed:** Yes No N/A**Qualified Welders:** Yes No N/A**Verified Joint Fit-up:** Yes No N/A**Approved Drawings:** Yes No N/A**Approved WPS:** Yes No N/A**Delayed / Cancelled:** Yes No N/A**Bridge No:** 34-0006**Component:** OBG**Summary of Items Observed:**

Caltrans Quality Assurance (QA) Inspector, Mike Hasler was present to observe the fitup, welding and related activities associated with the fabricating of Caltrans Orthotropic Box Girder (OBG) and Tower, for th

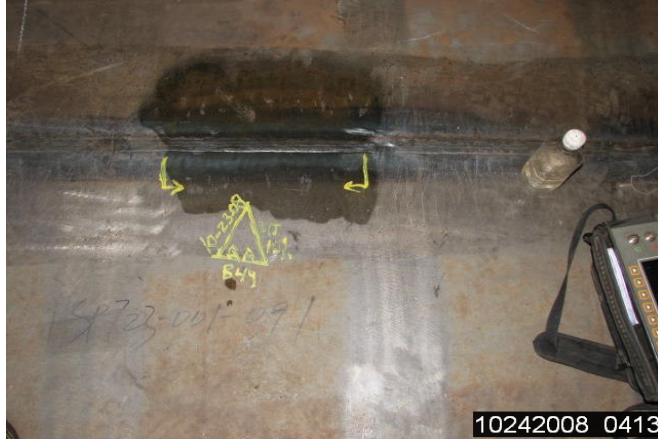
Bay 3: Caltrans QA inspector performed ultrasonic test (UT) inspection per ZPMC notification of witness inspection, document number 001265. The OBG side plate subassembly identified as side plate welds, SP617-001-073, SP763-001-073, SP485-001-099, SP537-001-099 and SP723-001-091. Caltrans QA inspector observed that ZPMC QC-UT has tested and accepted welds. Caltrans QA-UT weld coverage was approximately ten-percent. The welds appeared to be in conformance with the project specifications. See Caltrans Ultrasonic Test Report (TL-6027) dated, October 23, 2008 for additional information. The following digital picture illustrates subassembly SP723-001-091 QA-UT inspection.
